Case study

Restoring an iconic World War II torpedo bomber from nothing but wreckage

Fleet Air Arm Museum, Yeovilton, UK

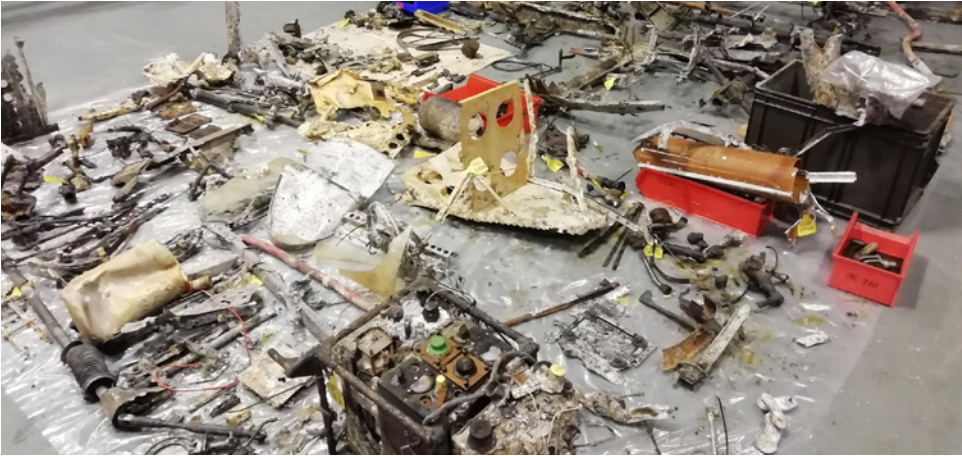
Fairey Barracuda parts recovered from several different crash sites
